12 storey tower fully restored for 2011

Stone arcade on brink of collapse

Undermined garage causes partial retaining wall collapse

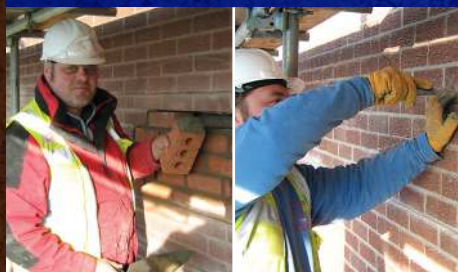
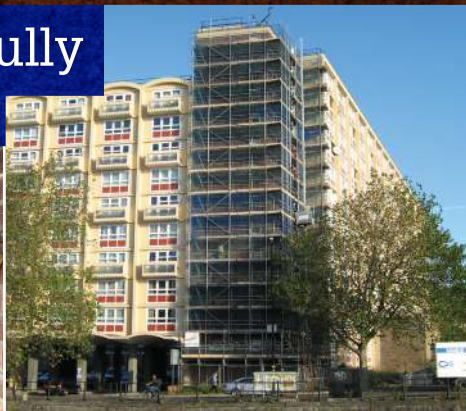
ASRS were asked to investigate and provide a solution to the connecting tower between two residential housing blocks, that had suffered from cracking and movement, as part of planned maintenance by a housing association.

An extensive external survey of the masonry was carried out, it was discovered that the brick slips were failing, some areas had cracked due to the structural loads and some areas needed to be rebuilt.

Three bed joints per floor were reinforced creating helibeam in the masonry which were wrapped around the tower to distribute

the structural loads and reconnect separating masonry. Specialist remedial wall ties were installed to pin the brick slips back to the concrete floors. Each brick slip was pinned back using a resin fixed tie with a total of 174 ties per floor. Areas of brickwork that were beyond repair were removed and replaced and then brick tinted to match the existing to provide an almost invisible repair.

The works were carried out in less than 3 weeks fully restoring the structural integrity

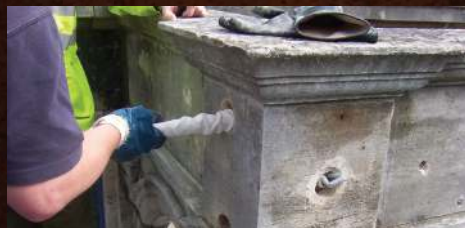
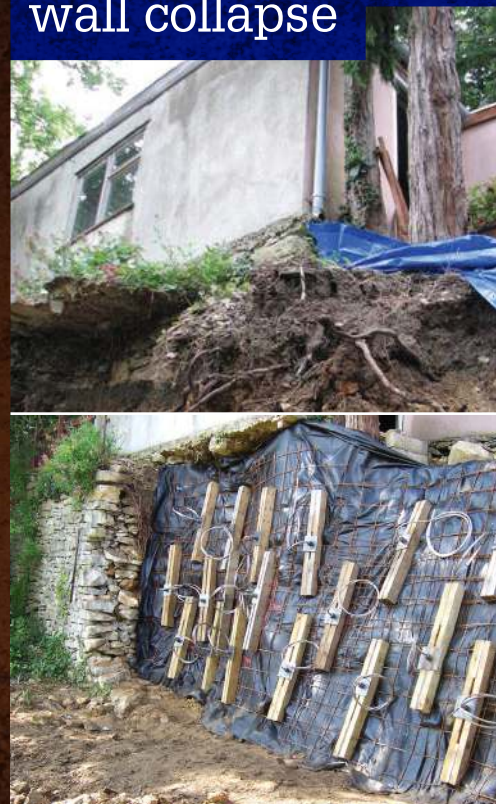
Due to a partial collapse of this retaining wall ASRS were asked to design a permanent solution to stabilise the ground.

Firstly the slope / cut face had to be restrained using platipus anchors, A142 mesh was fitted to timber noggins to restrain any further soil movement.

As the wall was reconstructed the anchors were incorporated into the new retaining wall to prevent any further movement. The wall was rebuilt using locally sourced stone and traditional lime mortar pointing restoring the original aesthetics of the wall.
